Baltimore City Community College Facilities Master Plan Liberty Heights Campus

October 20, 2020

Maryland Department of General Services
Project Number: CC-000-190-003

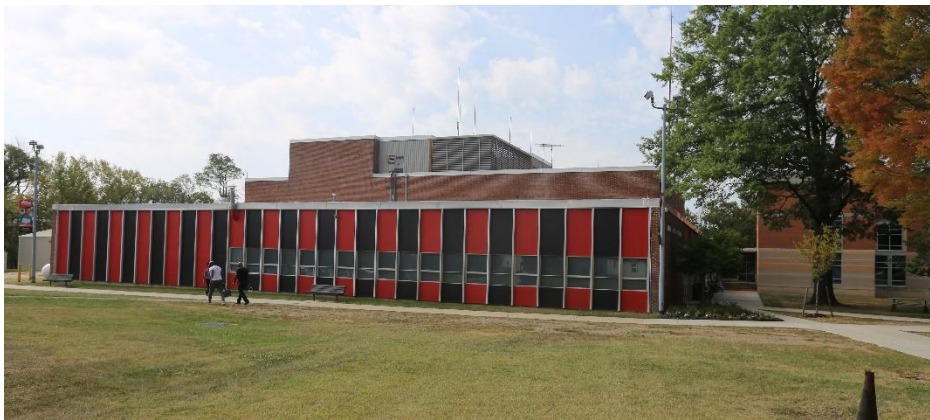
Figure 4-9 - Fine Arts exterior

The Fine Arts exterior is dated in appearance and in performance, and requires replacement.

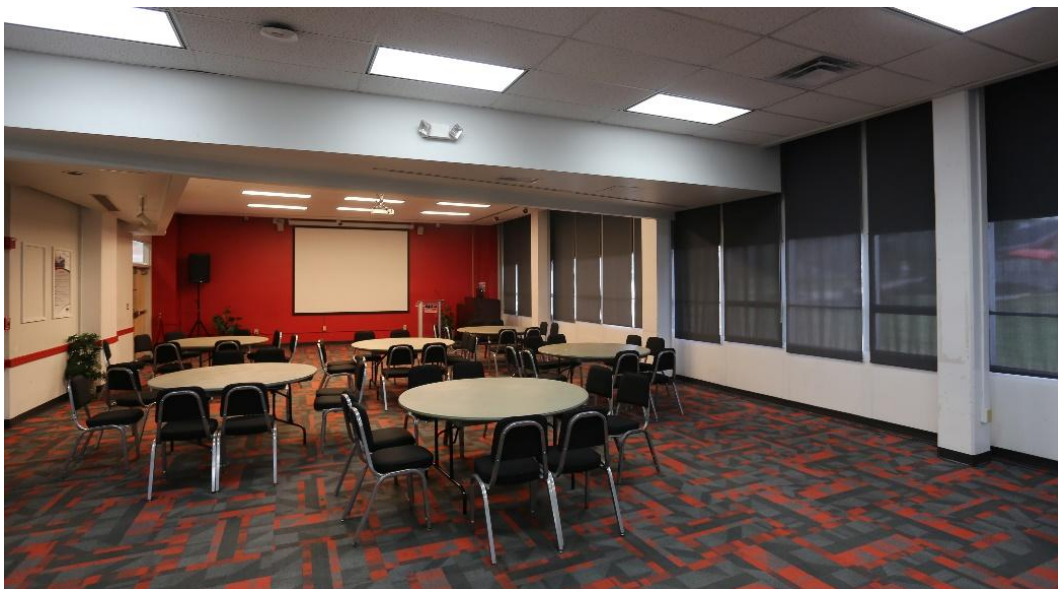
Figure 4-13 - Fine Arts conference area

Finishes in the Fine Arts wing are worn, and require updating or replacement.

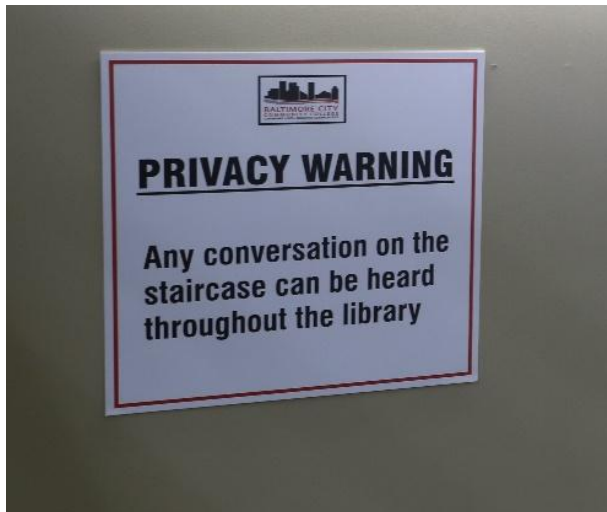
Figure 4-22 – Library sign

The library is in unsatisfactory condition, with obsolete envelope, HVAC and functional arrangements. It urgently requires renovation and updating to meet functional demands and to address out-of-date systems. It reflects its original role as a repository for bound books, and does not meet current curriculum requirements for electronic media and information-sharing.

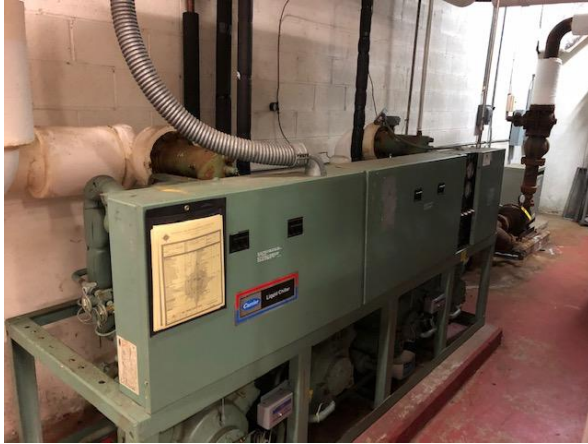
Figure 4-27- Chiller and Condensing Unit

The system uses chilled water provided by a direct expansion Carrier chiller located in the basement. It appears to date from a renovation in 1988. The entire output of chilled water feeds the dual duct VAV air handler also in the basement. The chiller has reciprocating compressors which have not been offered on chillers of this size for at least 25 years. The condenser also appears very old as it has many signs of damaged fins, very bad paint and unreadable nameplates. The condition of this system is poor. The compressors used in this system also have many moving parts unlike modern compressors for systems of this size which have a single moving part making it easier to maintain them. The chiller would not be recommended for reuse.

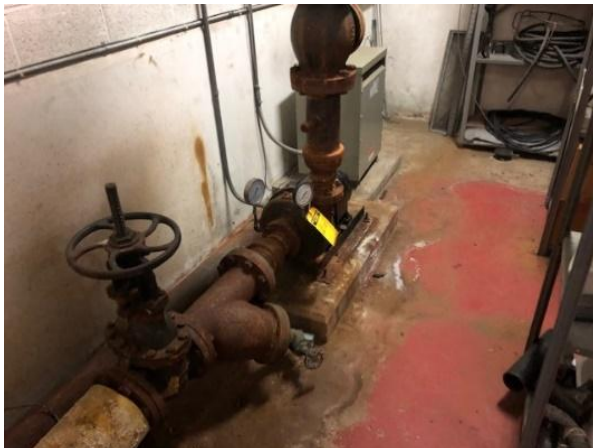
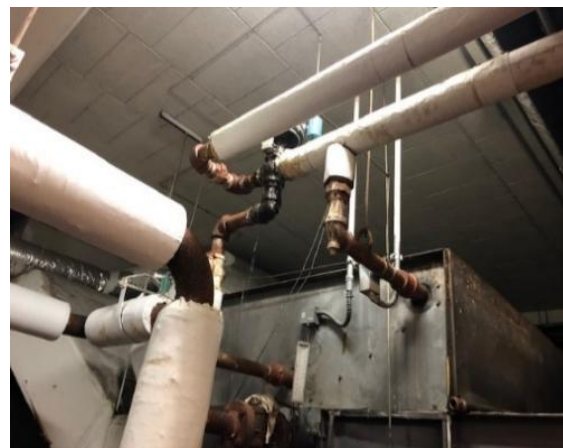
Figure 4-29 & Figure 4-30 – Library Piping Showing Missing Insulation and Leaks

The chilled water piping also looks very dilapidated. Many instances of missing insulation, no air separation or chemical treatment was noticed. The interior of the piping is most likely in poor condition. The simplex pump looks very old as well. Would not reuse piping in any major renovation.

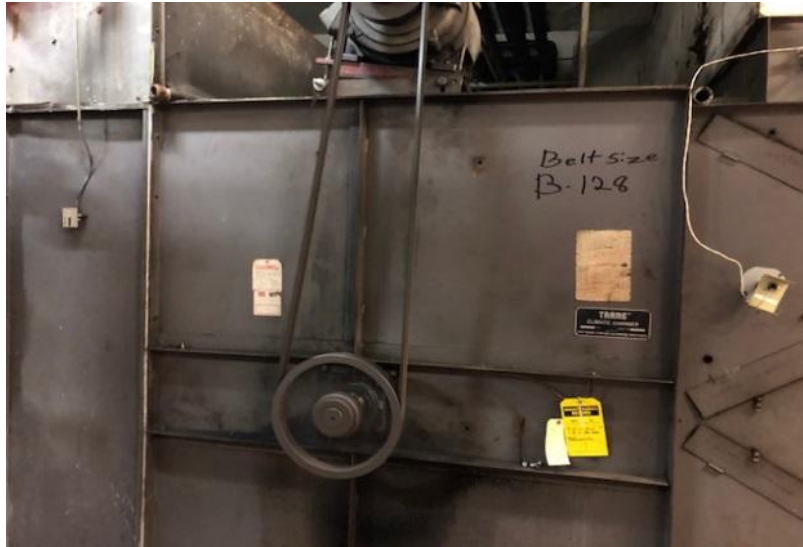
Figure 4-31 - Existing Dual Duct AHU

AHU: The existing AHU appears to be very old. As dual duct has not been a preferred system for at least thirty years. Dual duct terminal units and systems sold today are for replacements, not new installations. The unit is not damaged and does not appear to be leaking, however it does have an aged appearance. This system has no VFD on the fan therefore; the terminal unit basically serves as mixing boxes to mix the air from the two decks

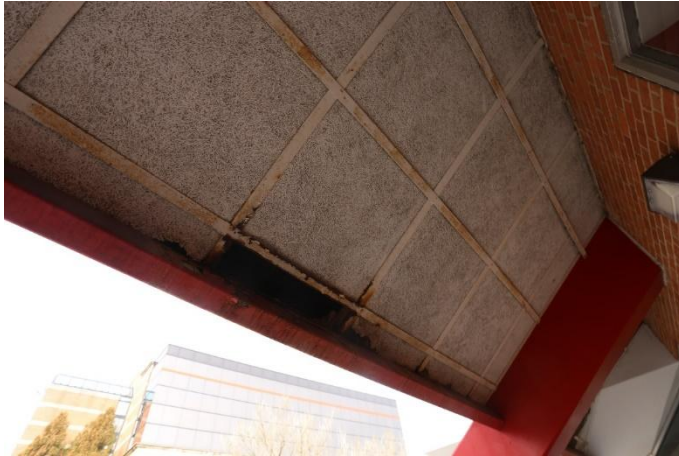
In common with other buildings built at about the same time on campus, the Physical Education Center has low structural clearances and restrictions on structural penetrations. Cement fiber roof deck panels (Tectum) are showing age and moisture damage in some locations.

Figure 4-34 – Damaged Tectum and framing at gym roof overhang

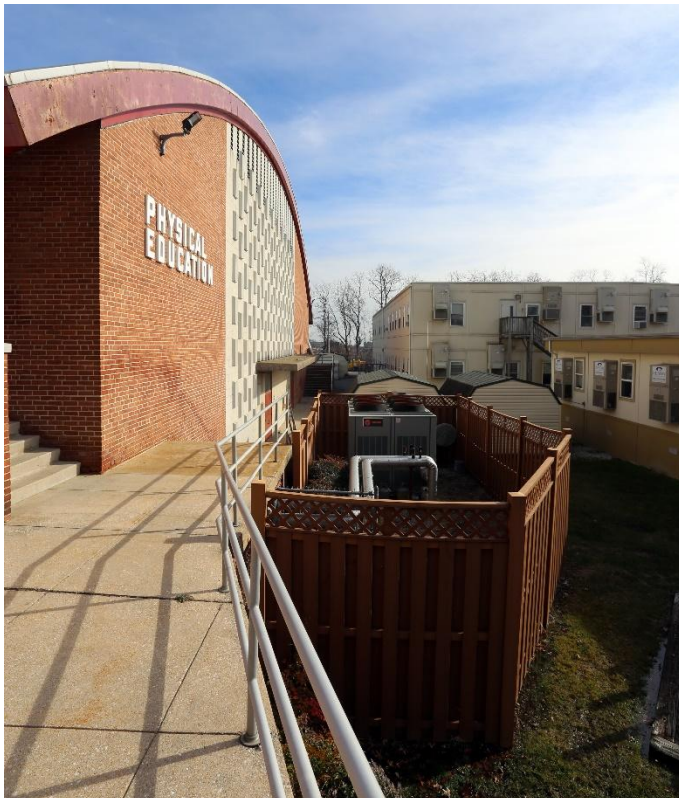
Figure 4-35 – Mechanical clutter and encroachment at the front of the gymnasium

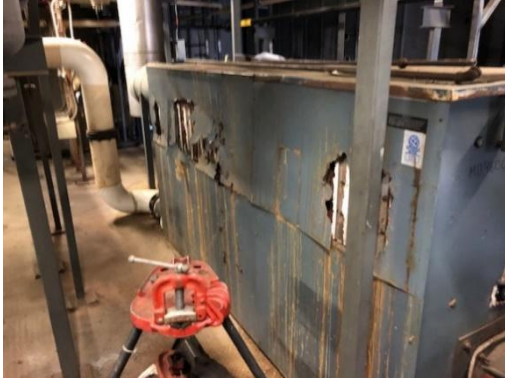
Figure 4-48 - Cast Iron Boilers Serving Life Sciences Building

Heating Water is provided by two dual fuel cast iron boilers. The boilers are located in the penthouse of the building. The boilers have water distribution by duplex constant volume pumps. The existing boilers seem to have some age on them as evidenced by the rusted condition of the outer casing.

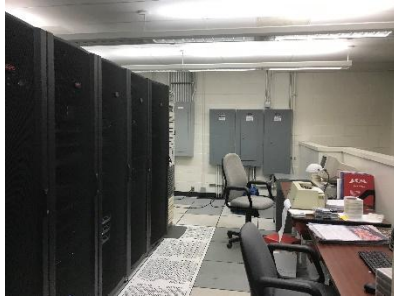
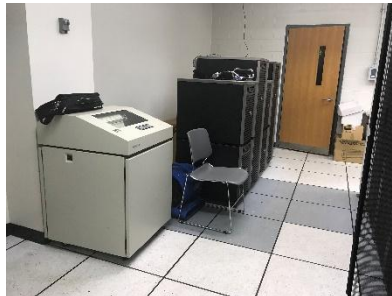
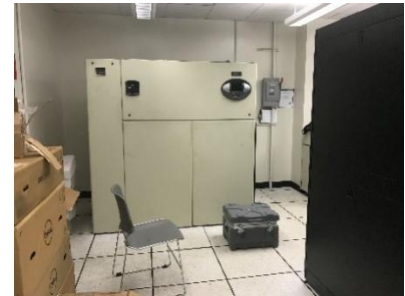
Figures 53, 54 & 55 Existing data room, data equipment racks and Existing UPS system

Like power outlets, tel/data outlets are a combination of recessed and surface mounted. Surface mounted data outlets were noticed in ticket office, back rooms, etc. with raceway going to the suspended ceiling. Since the building is not that old, the outlets have to be checked individually. Otherwise, they are in fair condition.

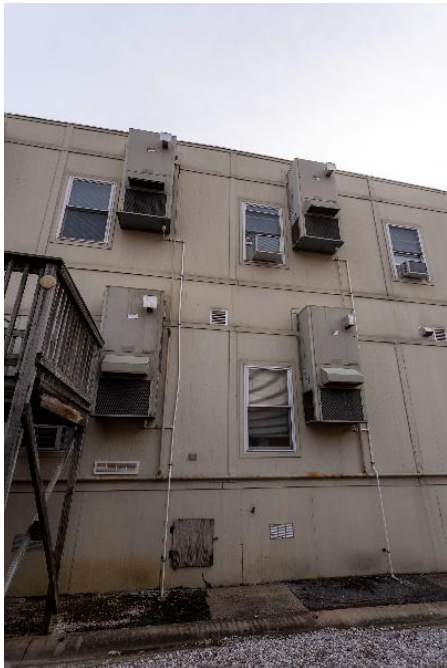
Figure 4-59 - Typical PTAC units

Condition: The PTAC units are all in serviceable condition. No long range planning is needed for such a system. The individual units can be replaced as required. These units are very common for prefabricated temporary structures as these appear to be.

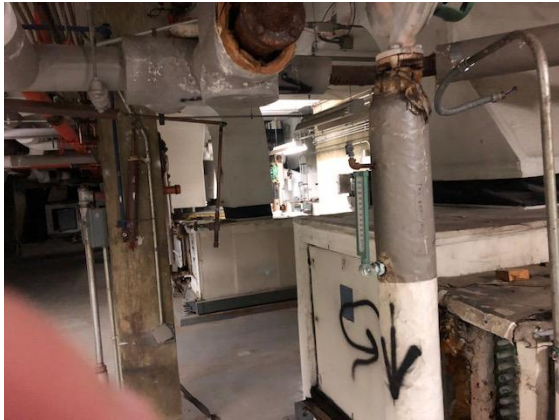
was demolished. The existing air handlers are constant volume, four pipe units. They appear to be the only users of the chilled water produced from the roof top chiller. There were many abandon air handlers in the basement mechanical room

Figure 4-66 - Abandoned AHU in Basement Mechanical Room

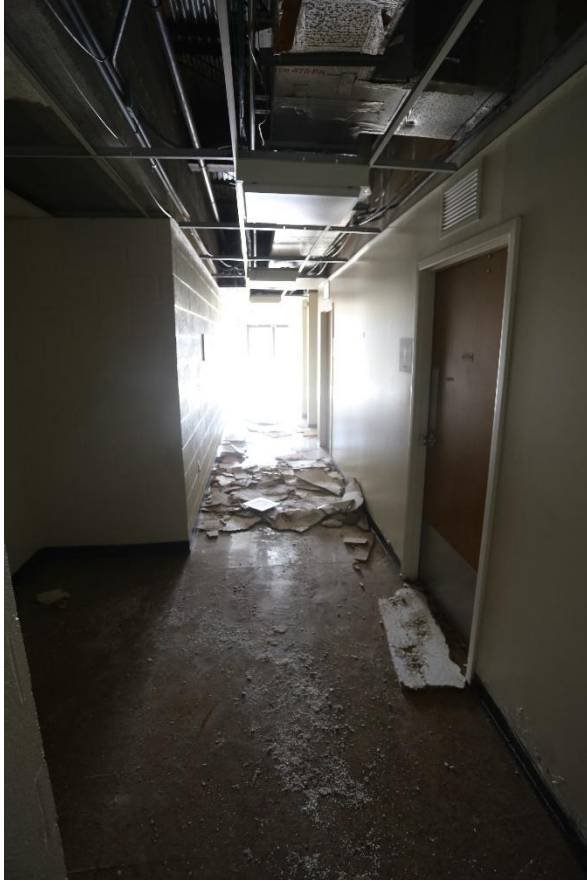
Figure 4-77 – Interior damage

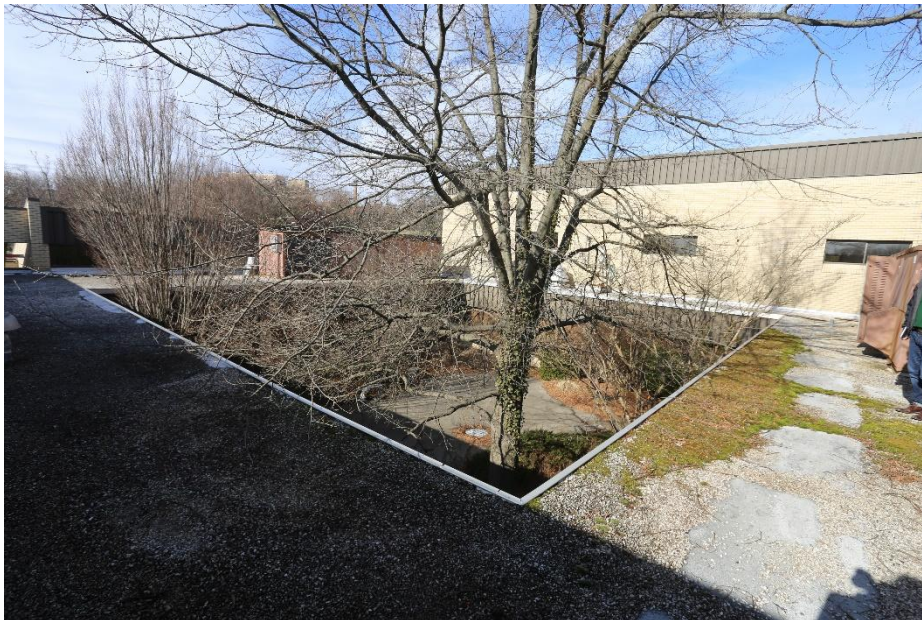
Figure 4-79 – Roof and courtyard

The roof has failed and requires complete replacement and possibly substantial decking repair. The built-up roof is mossy and eroded. Rooftop HVAC units are long overdue for replacement and are physically deteriorating and only partly functional.
