Baltimore City Community College Facilities Master Plan Liberty Heights Campus

October 20, 2020

Maryland Department of General Services
Project Number: CC-000-190-003

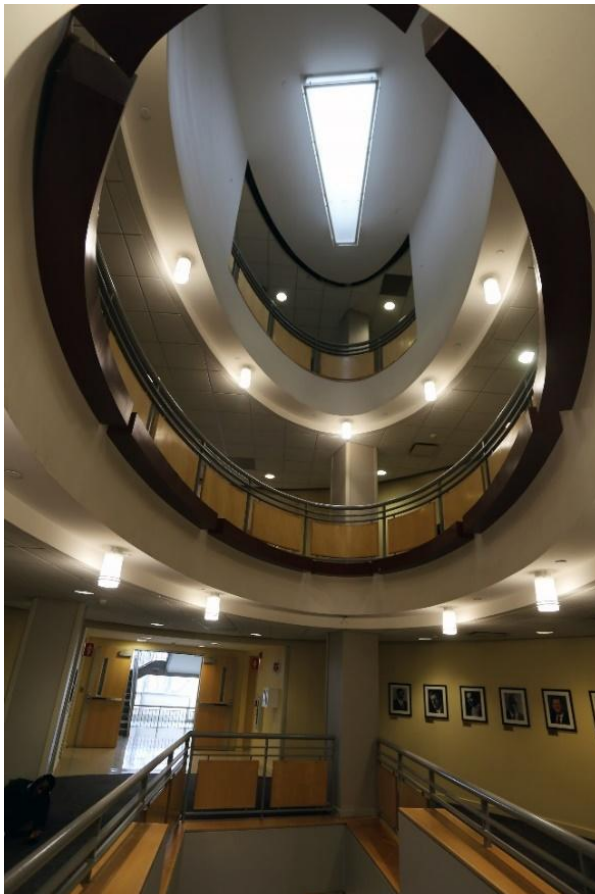
Figure 4-3 - Main Building atrium

The center of the Main Building features a small four-story atrium. It is an attractive landmark, but cramped and out of scale with the rest of the building,

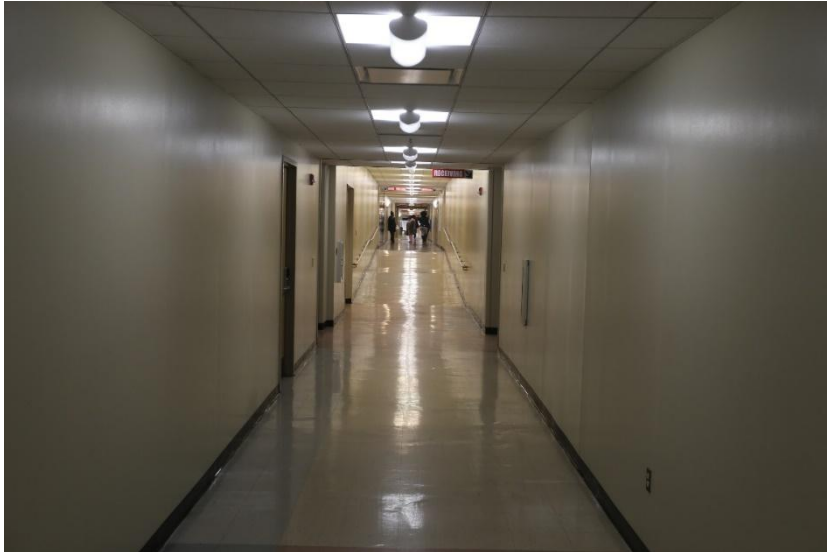
Figure 4-4 - Main Building corridor

Wayfinding in the Main Building is difficult, given the sprawling nature of the building. Hospital-style wayfinding markers have been used in some locations to give direction.

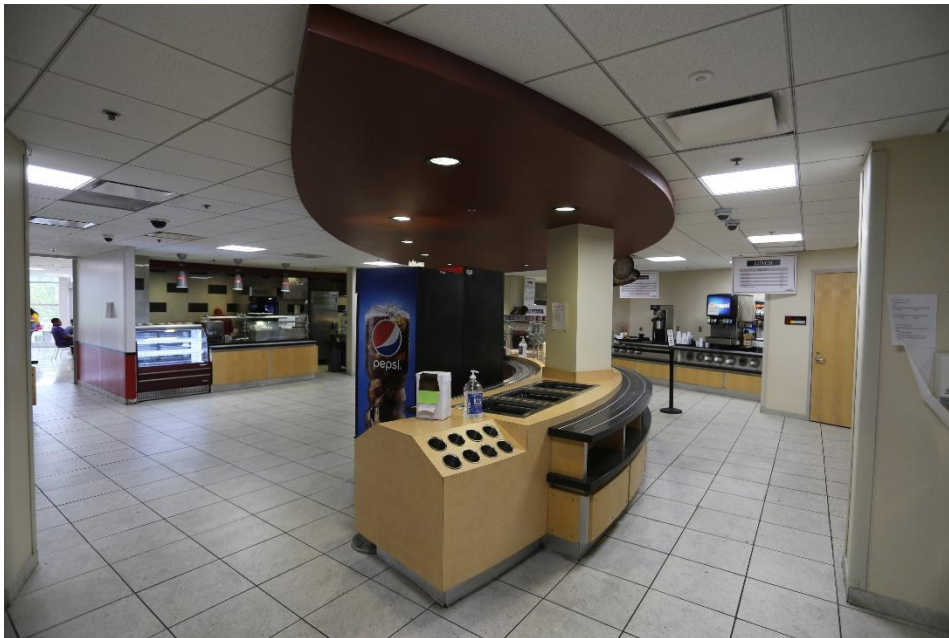
Figure 4-7 - Main Building dining

The dining area in Main Hall is attractive and updated, but smaller than needed for the campus, especially since the campus has no nearby off-campus dining options. A small outdoor terrace expands options in fine weather, but the food service component is significantly under-sized. The bookstore is, by contrast, oversized, and it is recommended that some of the bookstore be repurposed for snacks and coffee to remedy the shortfall in dining space.

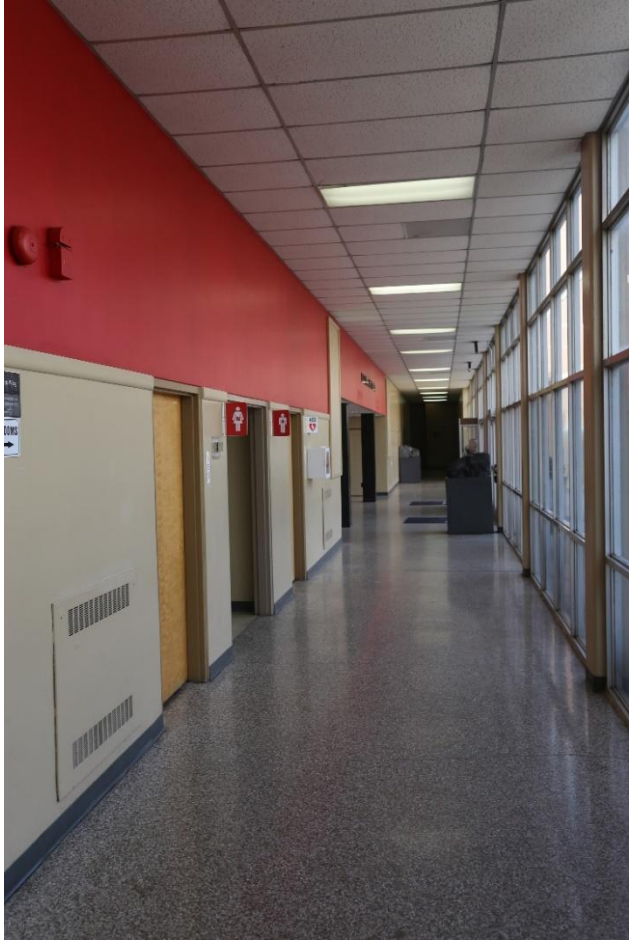
Figure 4-10 - Fine Arts lobby

The Fine Arts exterior is dated in appearance and in performance, and requires replacement.

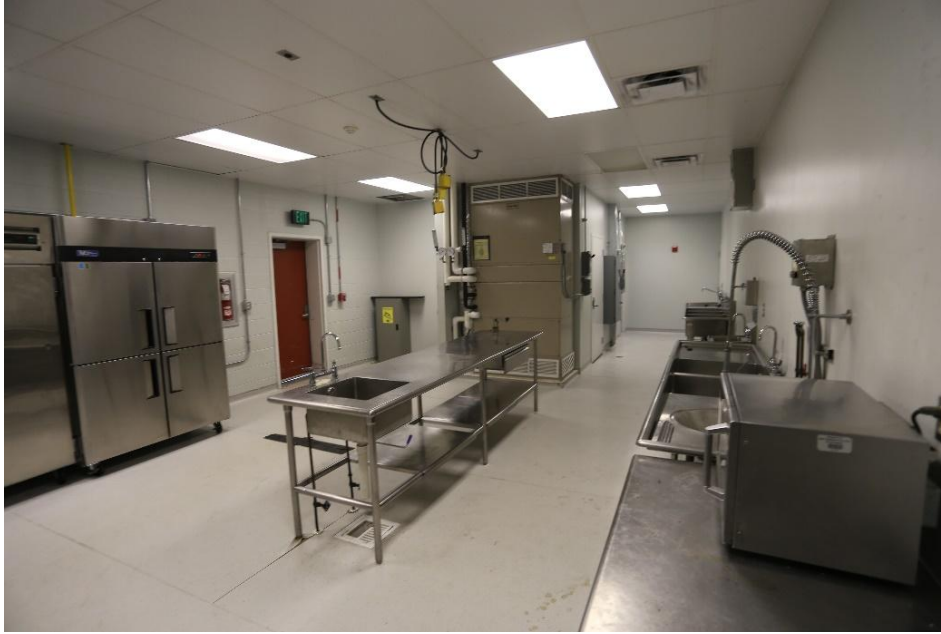
Figure 4-14 - Fine Arts kitchen area

Finishes in the Fine Arts wing are worn, and require updating or replacement.

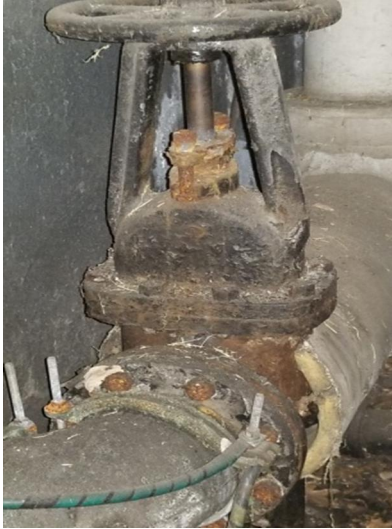
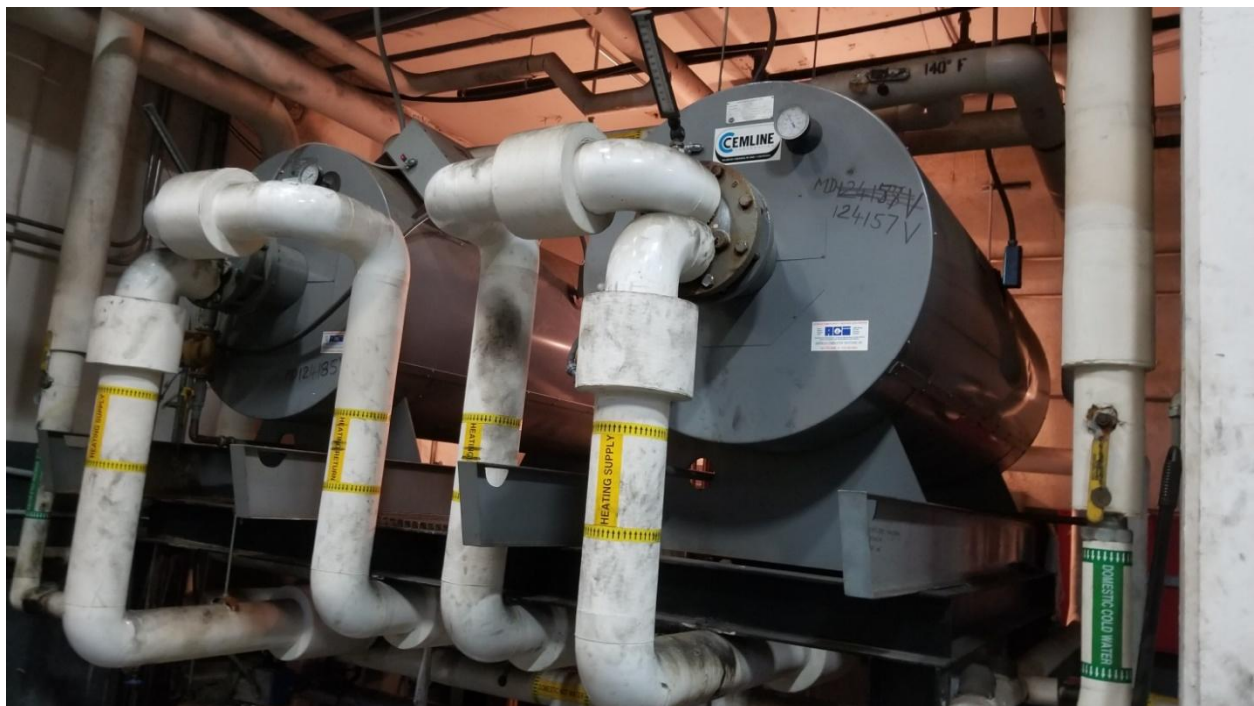
Domestic water service is from a 20-inch City Main at Liberty Heights Avenue. A water meter vault is located at the main water service on the sidewalk. Backflow preventer is not installed at this 8-inch school main which distributes domestic water to each building on South Campus.

8-inch domestic water service enters the ground floor Boiler Room into Main Building. This incoming service without backflow preventer does not meet the current code and local water authority requirement.

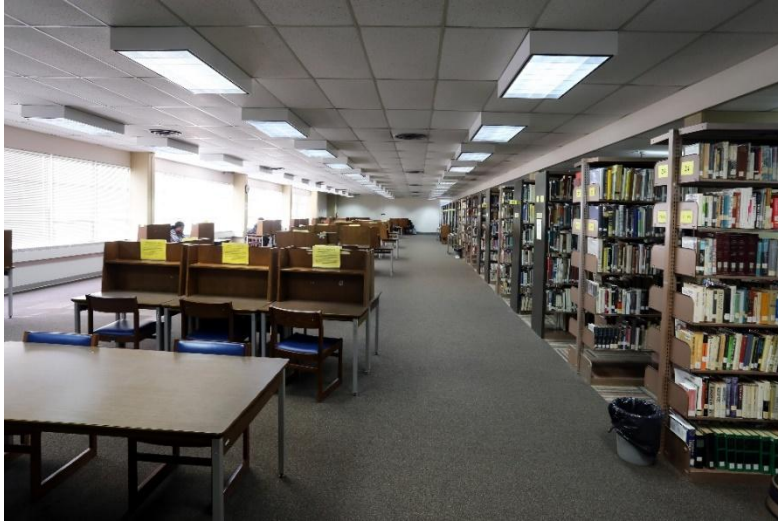
Figure 4-23 – Library interior

The library is in unsatisfactory condition, with obsolete envelope, HVAC and functional arrangements. It urgently requires renovation and updating to meet functional demands and to address out-of-date systems. It reflects its original role as a repository for bound books, and does not meet current curriculum requirements for electronic media and information-sharing.

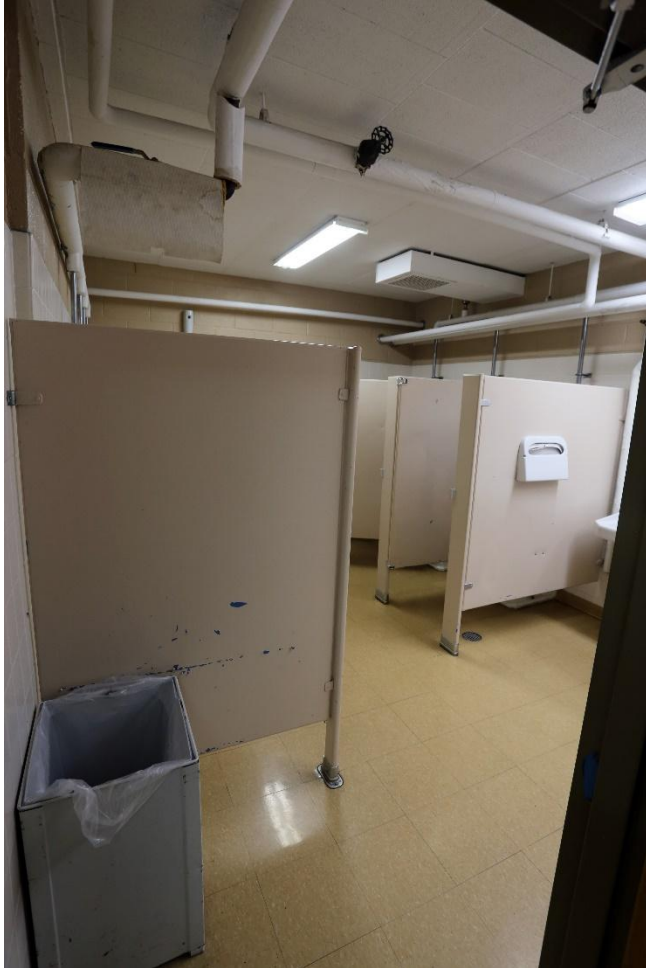
Figure 4-25 – Basement toilets

The building is accessible from the main entrance. An elevator has been retrofitted behind the main stairs, opening into common space on the first and second floors, but ending in a classroom space in the basement. Since there are toilets only on the

second floor and in the basement, and since the bulk of the basement facilities represent 2/3 of the toilets in the building, access to toilets is awkward at best, and unavailable if the classroom is in use or secured. Railings and stairways do not meet current ADA standards, and alarm systems are not up to current standards.

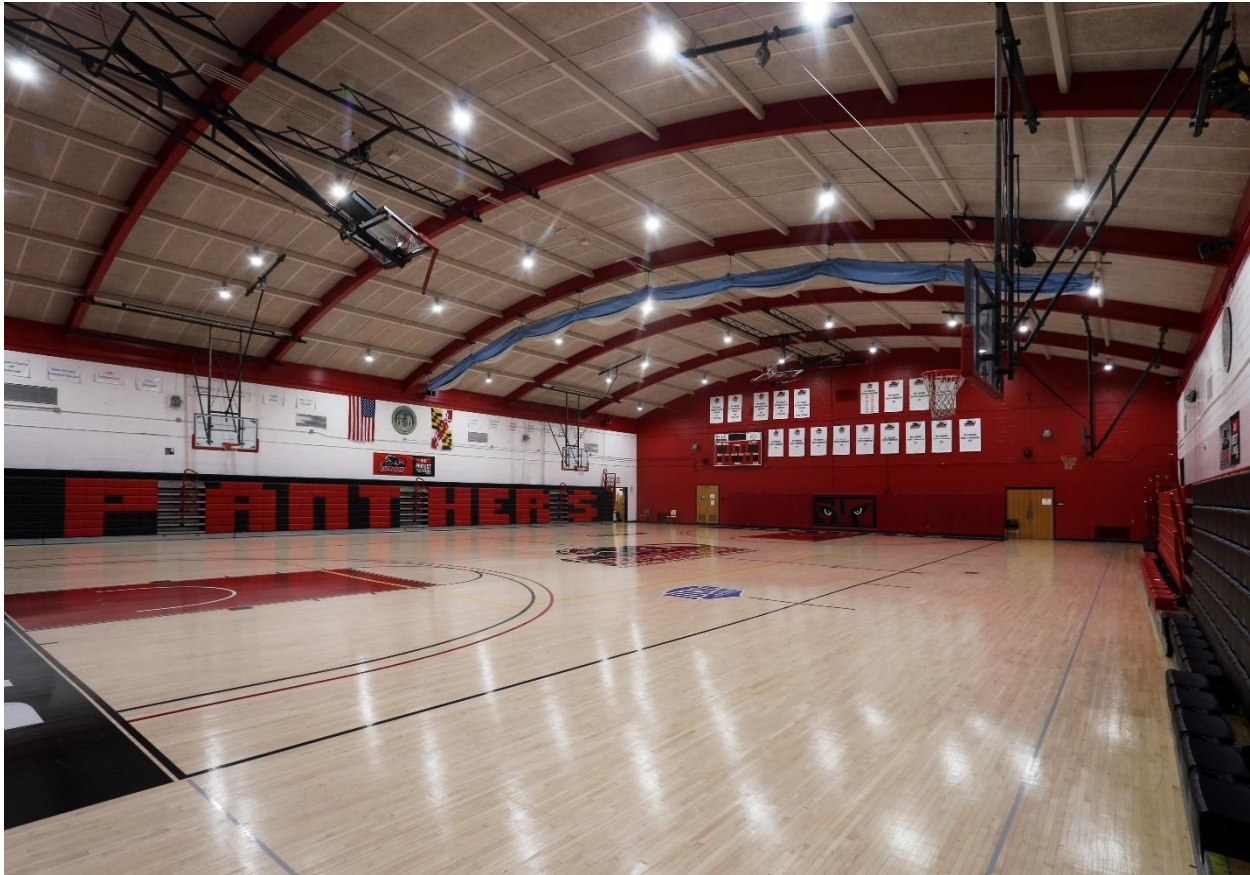
Figure 4-33 - Interior of the arena

As noted in the attached condition assessment, the Physical Education Center is in satisfactory condition, but will require substantial work in the mid-term horizon to address deferred replacement of systems and finishes, and to bring the facility up to current accessibility standards. Its comparatively isolated location on the campus and the imposition of temporary modular buildings such as the Facilities Building and Harper Hall have harmed its prominence and connection to the campus.

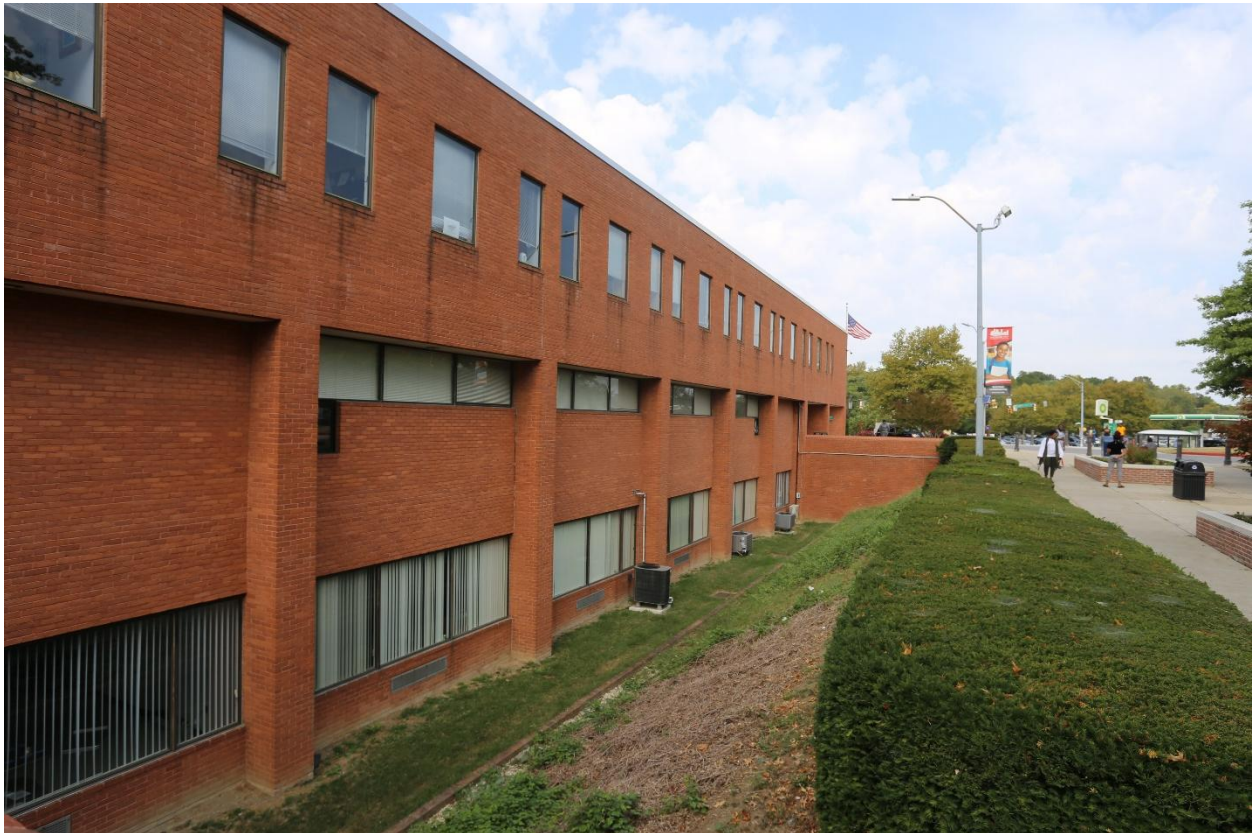
Figure 4-38B – The Nursing Building main façade and the “moat”

The Nursing Building has access from grade at two levels, occupying the slope of a hillside. It is somewhat isolated from adjoining circulation by the fall in terrain. Since it was constructed before ADA provisions were formulated, it lacks most accessibility features, and only partial retrofits have been attempted. Stairs, the elevator, hardware, door clearances, life safety systems and toilet facilities require comprehensive rework.

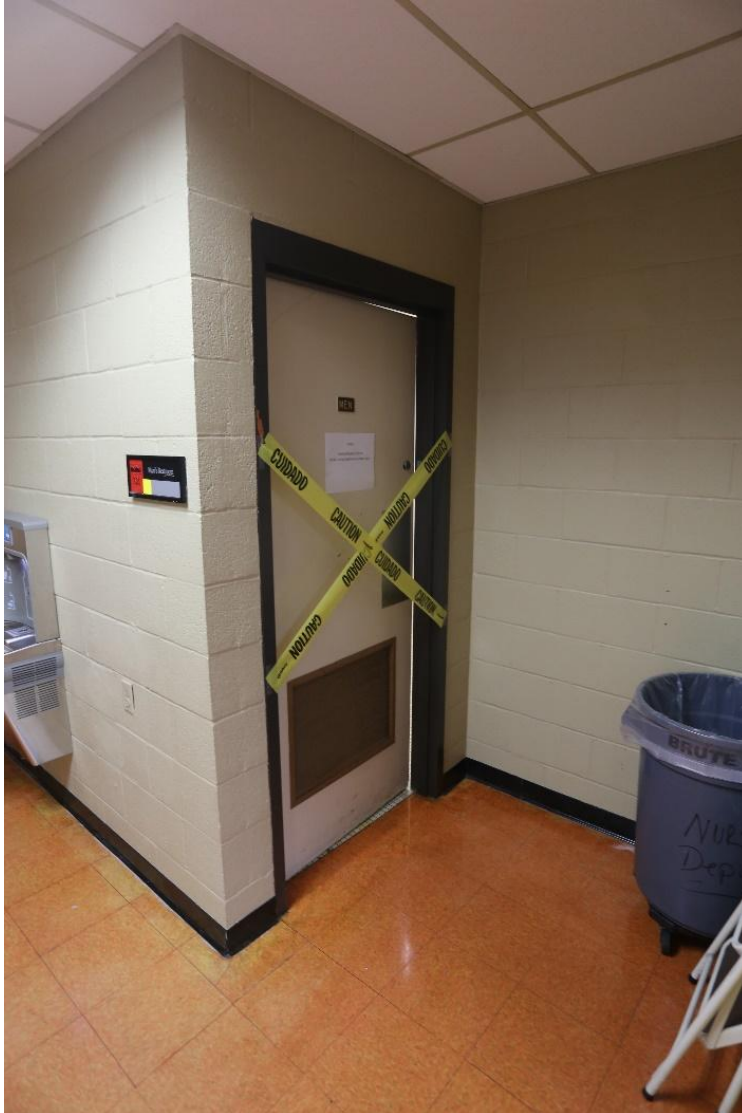
Figure 4-40 – Toilet out of service

Many of the plumbing fixtures appear to have been replaced recently, and many are provided with relatively new proximity controls. However, the appearance of the overall toilet rooms are worn and in need of renovations. Many of the fixtures and trim could be salvaged during a renovation project.

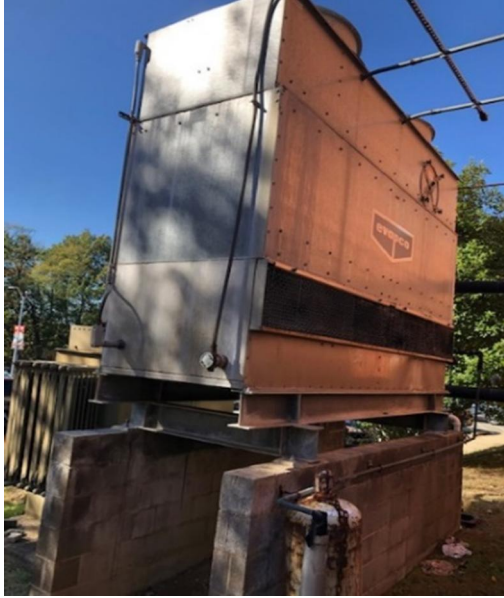
The building has a water-cooled chiller in the ground level mechanical room. The cooling tower is on dunnage on the ground outside the hydronic system. The system has constant volume pumps for the dual temperature water and the perimeter heating loop.

Figure 4-41 - Building Cooling Tower

All systems appear old though not decrepit. The cooling tower showed signs of scale and had no particle separation which may mean the interior of the piping and chiller tubes may have fouling. Some of the insulation has been repaired, but all piping was insulated. Some split systems and through the wall heat pumps were installed on the ground floor indicating the unit ventilators are not doing well. The system itself, the multizone is no longer designed for new systems. Multizones are mostly sold as replacement units as they have trouble with humidity control unless reheat is on year-round.

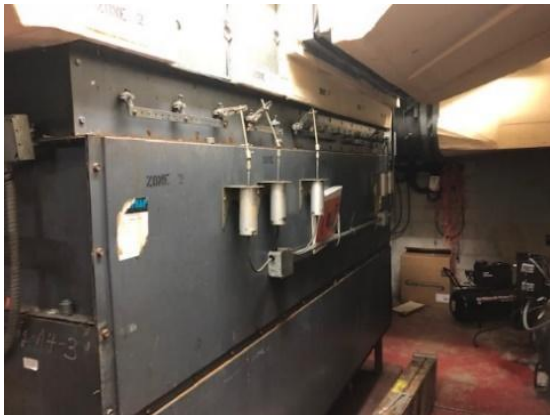
The air handling units serving the classrooms are dual duct units one per floor except for the ground floor which had unit ventilators using louvers for ventilation and a two-pipe system. The auditorium has its own dedicated air handler. All units are equipped with freeze protection pumps.

Figure 4-42 - Zone Dampers on Multizone Unit

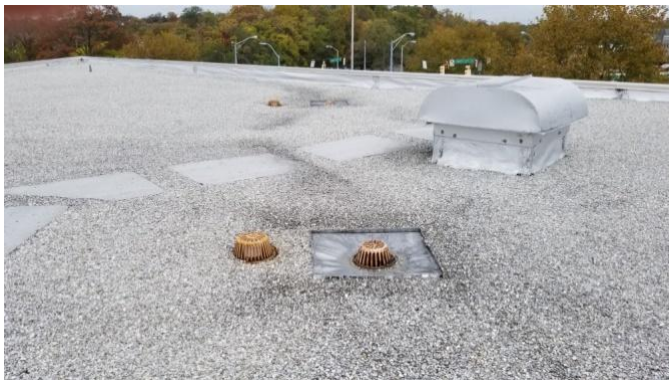
The building's primary storm drainage system consists of roof drains collecting and emergency overflow drain. Given the age of the building and lack of noticeable discharge points, we assume that is not independent emergency overflow piping drainage system.

Figure 4-43 – Storm drainage system

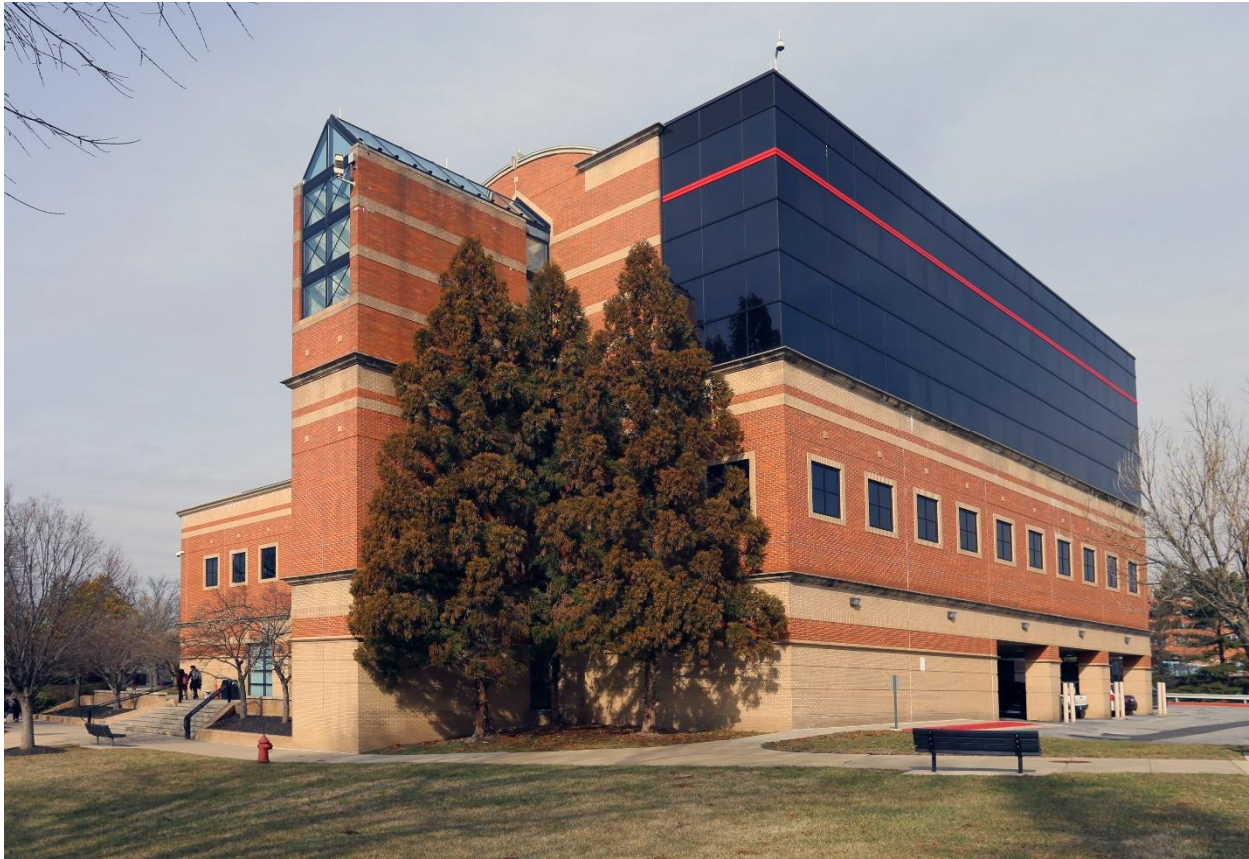
Figure 4-45 – Life Sciences from near the gymnasium

Classrooms and labs are in good condition, but are in almost constant use. Systems require a mid-life replacement program. The roof is a candidate for replacement. The elevators require replacement as well.

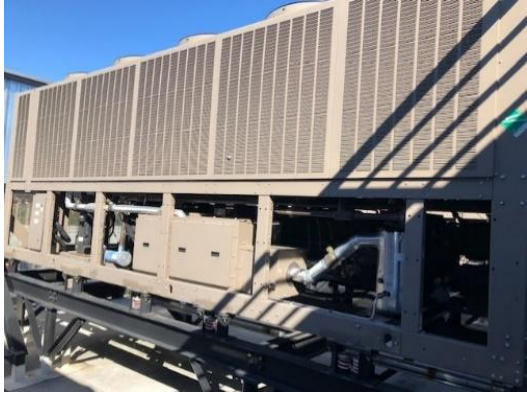
Chilled water is provided by three brand new air-cooled chillers located on the roof right outside the Mechanical Penthouse. Chilled water pumping is by a primary and secondary pumping. The secondary pump is a duplex constant volume chilled water pump. The primary pump is lead lag with a pump serving each chiller. The chillers and associated piping are new but it seems the existing piping indoors and pumps are much older and have signs of damaged insulation and rust.

Figure 4-49 - New Chillers

The air-cooled chillers are brand new and appear to have been installed within the past year. All of the piping going to the chillers looks new. The rest of the piping in the penthouse is old but not in bad condition. The heating water pumps and secondary heating water pumps appear old but in decent condition and are all operational. The primary chilled water pumps are inline pumps and are run down with numerous leaks and rust on all of the pumps. The boilers are also in bad condition. The casings are rusted out; however, no leaks were noticed. The air handlers also seem old but in good condition. The VAV constant volume reheat system is not as outdated as the systems in the library or nursing building but is generally used as a baseline system for all energy models.

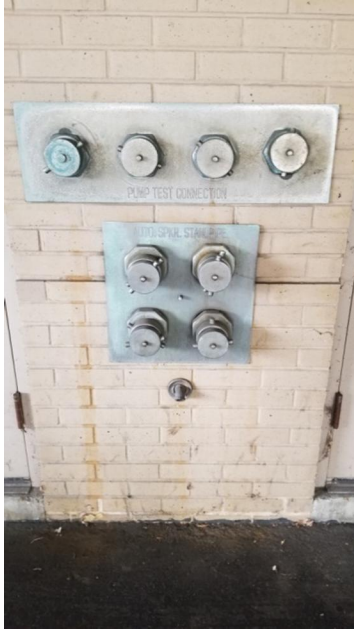
The building is served fully throughout by an Auto Sprinkler System with dry-pipe system to parking garage, wet-pipe system to heated area, and pre-action system to computer rooms. The sprinkler system is fed by an 8-inch fire service and boost with a fire pump. A diesel -engine driven generator is located in the penthouse for emergency power to accommodate emergency requirements.

Figure 4-50 - Fire pump test heads and Fire Department Connection

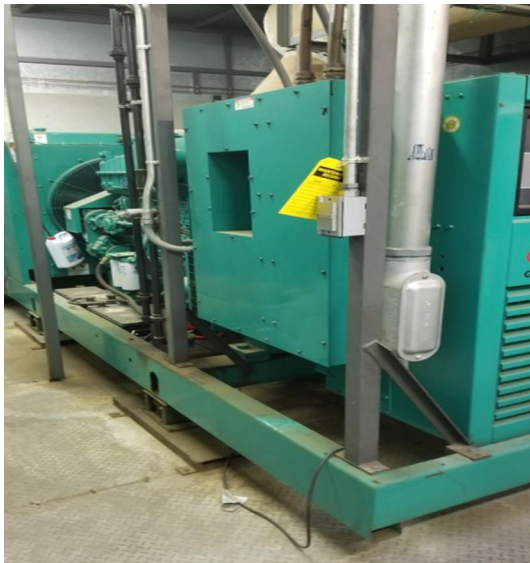
Figure 4-51 - Diesel-engine drive Emergency Generator

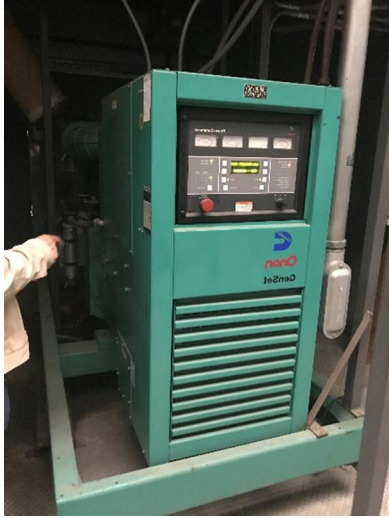
This MTU generator is used to backup all server rooms and data racks loads. This generator is almost new and in a good condition.

Figure 4-52 - Emergency generator

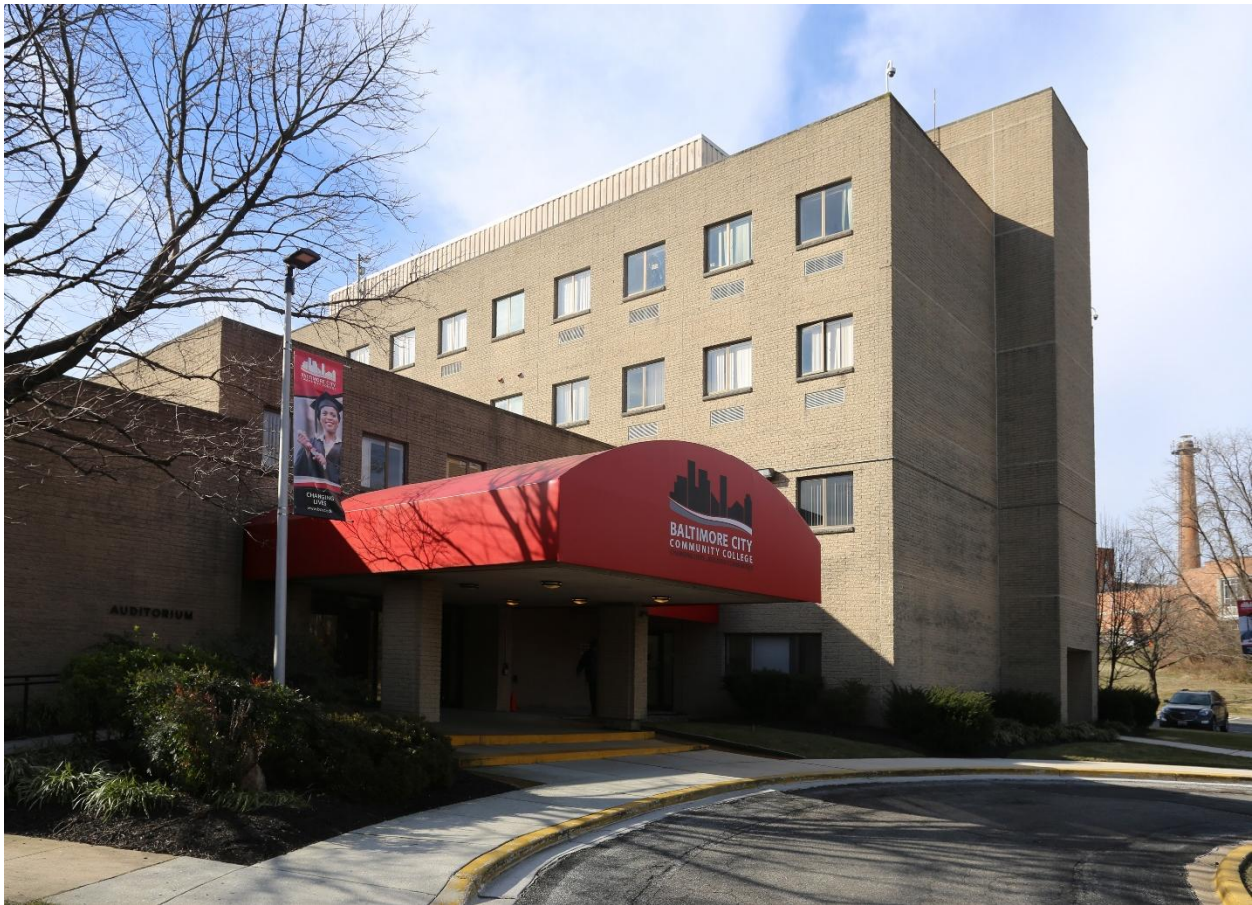
Figure 4-61 - West Pavilion entrance

A great deal of the building's footprint and peripheral spaces are devoted to infrastructure associated with its former use, serving the now-vanished hospital. The West Pavilion is recommended for demolition once it is no longer needed for float space during renovations.

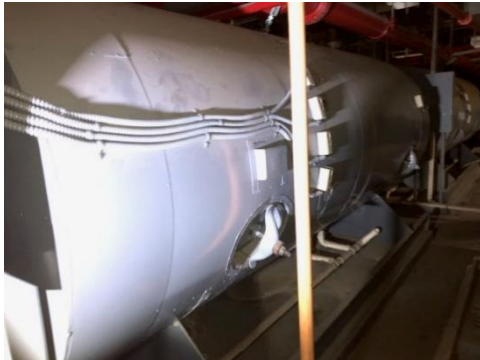
Heating Water Plant: There is an old electric boiler in the basement mechanical room with a constant volume pumping system. The boiler was sized for a much larger load than it is currently serving. It is assumed that it used to provide heating for the building that was torn down.

Figure 4-64 - Electric Boiler

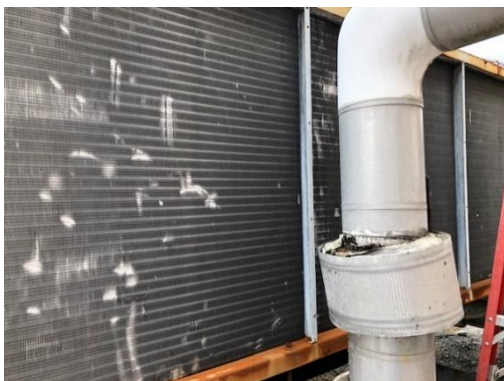
There is no central cooling plant. There is an air cooled chiller on the roof which serves limited parts of the building and an abandoned chiller on a lower roof that serves some abandoned air handling units. Most of the building is served by through the wall heat pumps with a ventilation unit providing ventilation.

Figure 4-65 - Existing Air Cooled Chiller

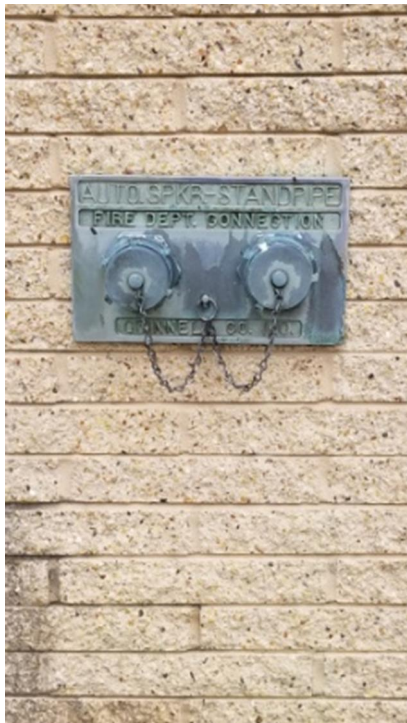
The building is served by a wet-pipe sprinkler system. The sprinkler system is fed by an 8-inch fire service and boost with a fire pump.

Figure 4-67 - Fire Department Connection for sprinkler system.

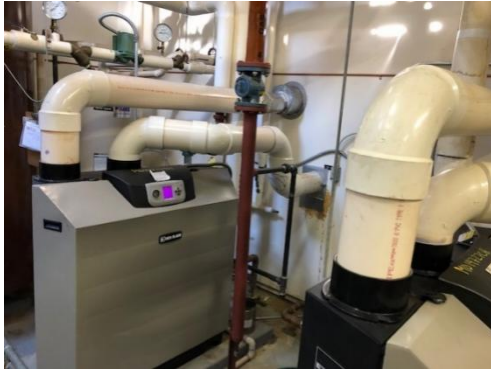
Figure 4-73 – Central Pumps

Central heating plant consists of two cast iron-direct vented condensing boilers located on an upper floor with two constant volume duty standby pumps circulating heating water.

The boilers and pumps appear to be in excellent condition. Everything in the boiler room appears to be installed recently and the condensing boilers are capable of much higher efficiency than any other boilers observed on campus. The main air handler units did not appear well maintained as filters are missing on some of the units, however, neither the AHU nor the rooftop condensers are in really bad condition. The configuration was not good because it did not allow space control of cooling. The system could be fitted with bypass terminal units to provide some control of cooling and with a makeup air unit very easily. If the budget allows, the air conditioning system should be replaced as bypass VAV is not even a baseline system for energy models.

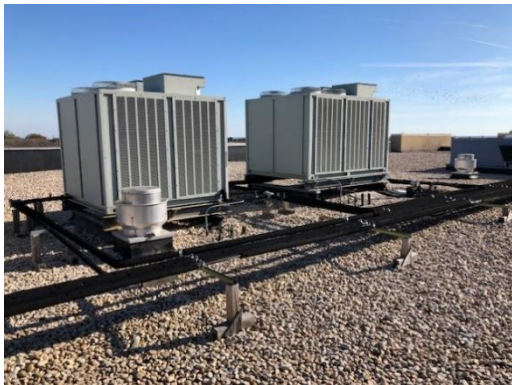
Figure 4-74 - Rooftop Condensers, One Per AHU.

There is no central cooling plant. Each floor has a D/X air handling unit as the primary source of cooling and ventilation. Other than a few split systems there is no other source of cooling.

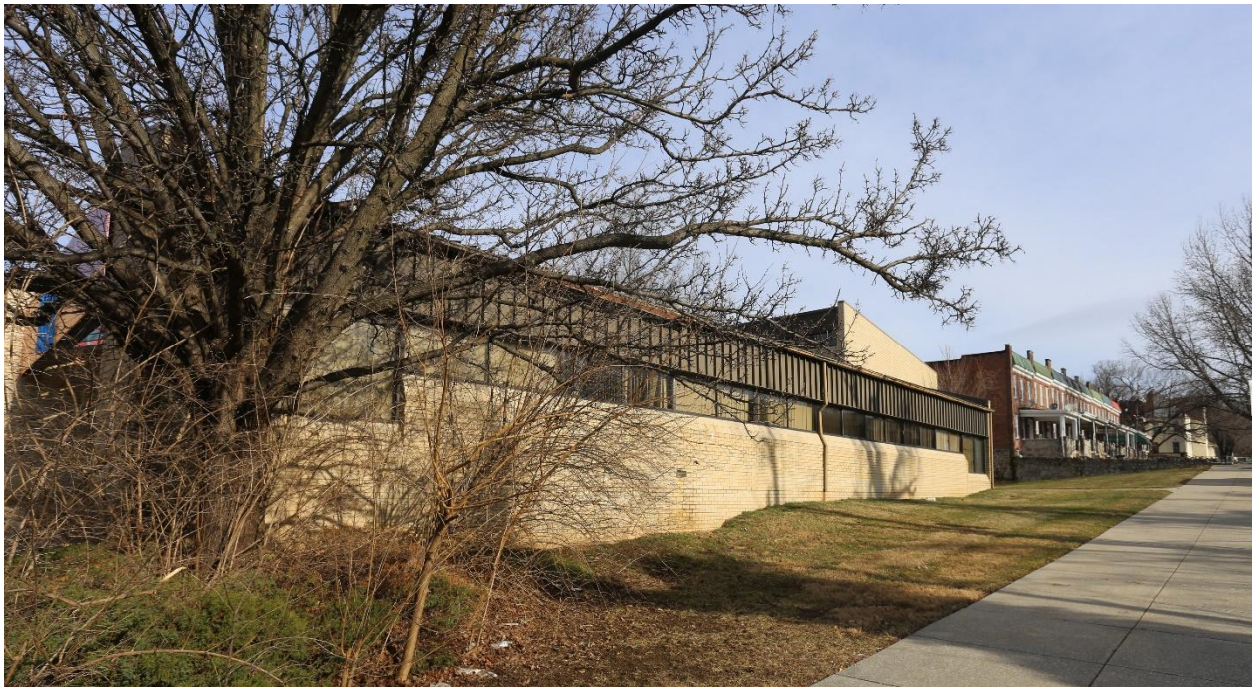
Figure 4-75 – North Pavilion exterior

The North Pavilion was built in the late 1990s as part of the former Provident Hospital medical campus, as a community mental health center. It was later used as a drug treatment center, and is currently unused. It has experienced environmental control problem and flooding, and mold is a continuing problem. Finishes are damaged and many ceilings have fallen out.

The building is highly specialized for its original use, and is not easily or efficiently adaptable to a new use. Construction standards are those of the 1990s, so the building envelope is substantially less efficient than current practice. Retrofit would be complex given the high ratio of envelope to floor area and the complex floor plan and elevations.

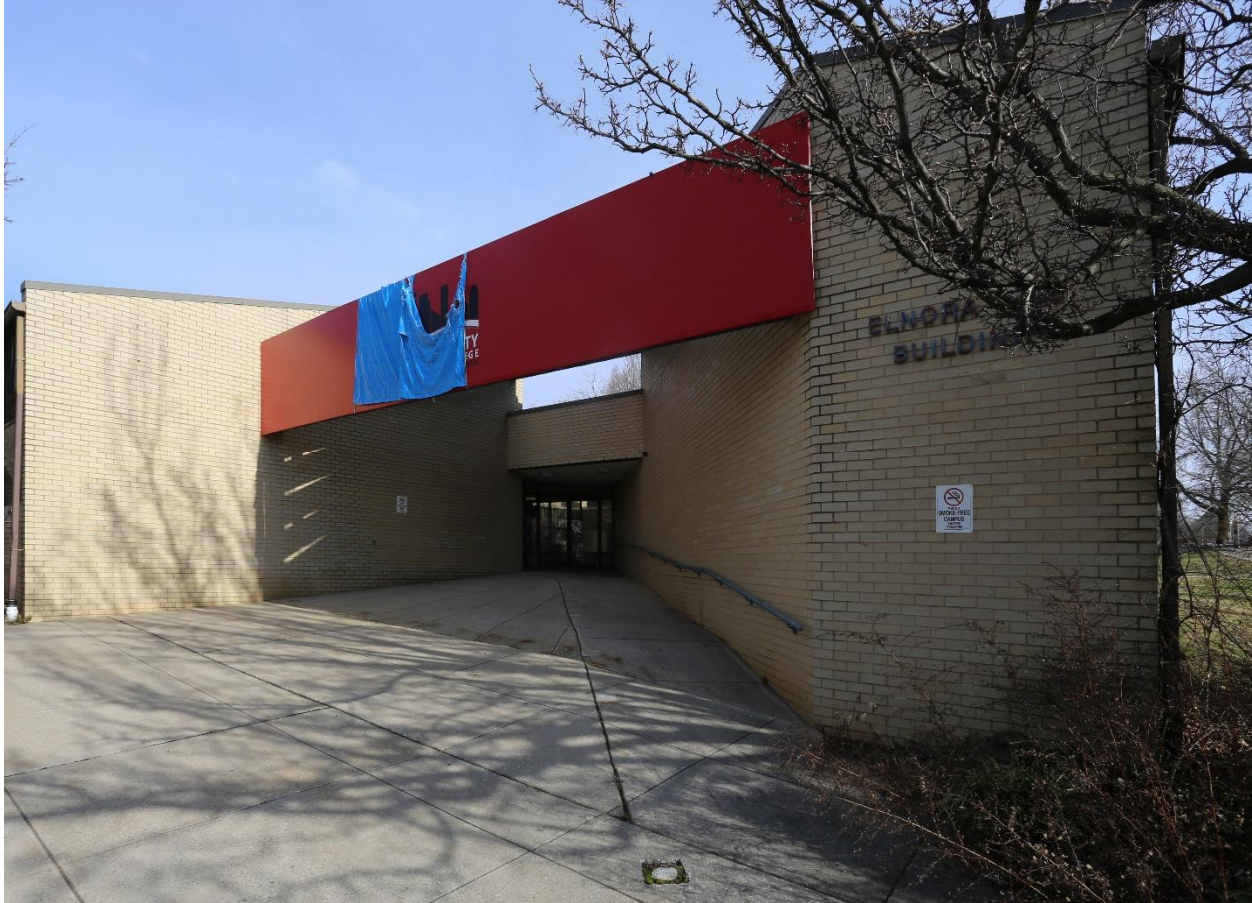
Figure 4-76 – Building entrance

The building is not presently accessible to the handicapped – the main entrance is a long, uninterrupted ramp sloping from the street to the door, and will require substantial modification to become accessible. With the tight internal arrangement and number of bearing walls, modification to current ADA standards would be complex.

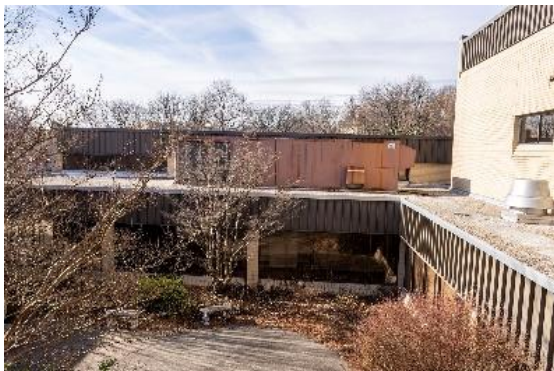
Figure 4-81 - Rooftop Unit and Exhaust Fan

All heating, cooling and ventilation is provided by three rooftop units located on top of the building. The rooftop units are gas fired and accomplish all ventilation, heating and cooling. The bathrooms have dedicated exhaust fans. The corridors and vestibules have electric heaters. There are no individual thermostats. The spaces served by the rooftop units are not capable of individual room control. It is assumed the entire zone is controlled by a single thermostat.

The condition of the existing system is poor. No date was found on the equipment label. The units are very old and the lack of individual room control would make them undesirable if the current room configuration was going to be maintained. The general decrepit condition of the building would indicate that a large renovation would be required to make it useable. It would be recommended to completely replace the mechanical system if the building was to be renovated.
